RESEARCH ARTICLE

Disaster waste management process: The case of February 6 earthquake

February 6 earthquake

Disaster waste

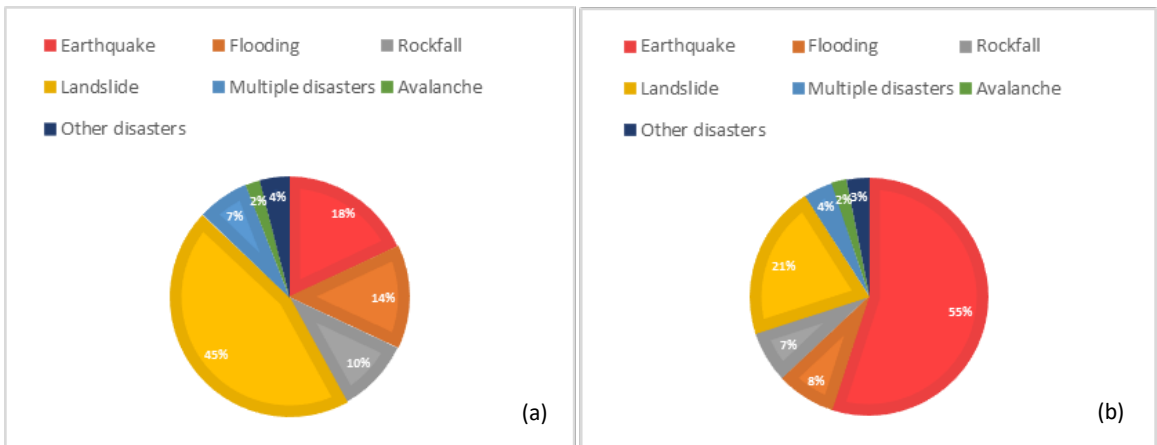
Fig. 3. (a) Disasters in Turkiye in terms of number, (b) Disasters in terms of number of people affected [10]

Although located in one of the most active earthquake zones on earth, Turkiye also faces many other natural disasters [10]. The graphs in Fig. 3 show the numerical distribution of disasters in Turkiye and their effects on people. While earthquake ranks second among the most common disasters with a rate of 18%, it ranks first in terms of the rate of people being affected by a rate of 55%.

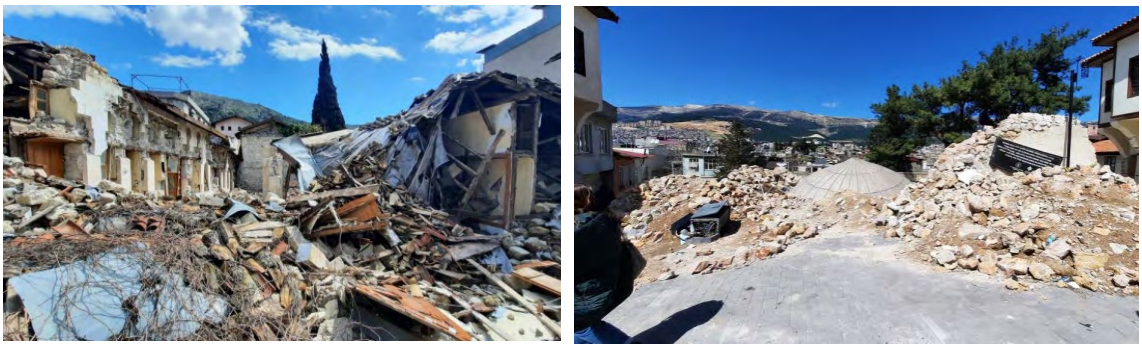
**Fig. 5.** Historical buildings in Hatay and Kahramanmaraş that collapsed and were heavily damaged after the earthquake [16]

There are historical and cultural buildings (mosques, inns, madrasahs, residences, bazaars, streets, etc.) with hundreds of years of history in the region. Turkish cultural heritage was also damaged due to the earthquake. Some of the masonry structures here were severely damaged due to the earthquake, and some were completely destroyed. Considering that these structures are representatives of the past and a source of information for the future, it is thought that they should be evaluated separately in the waste category [20]. In this context, historical building elements intertwined in debris studies should be separated from other debris wastes, documented and stored safely for later use in restoration works. In addition, considering that there are archaeological and urban archaeological sites in the region, the importance of conducting research in the area beforehand, considering it separately from other construction and demolition waste found there (especially underground), and carrying out debris removal work in a way that does not damage the historical texture should be taken into consideration.

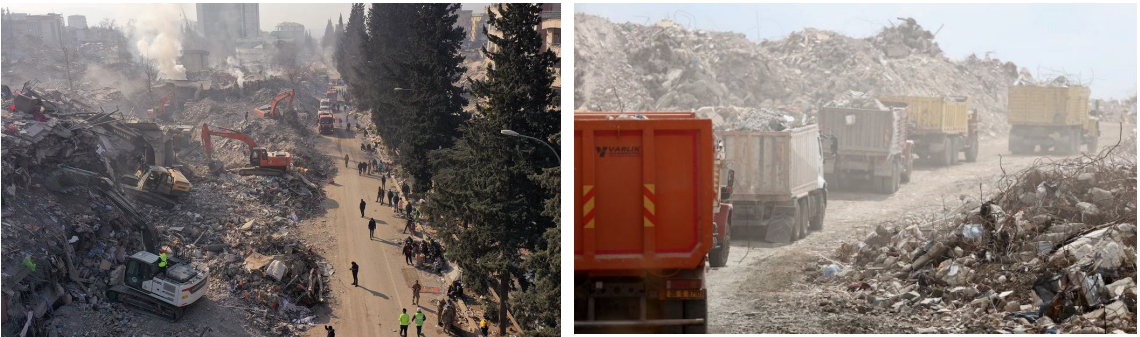
Fig. 6. Debris removal works after the earthquake in the region [35, 36]

released. It was observed that these substances were mixed into the air. It appears that even spending short periods of time in the area poses the risk of exposure to asbestos. This pollution in the city has increased the risk of respiratory tract, cancer and skin diseases in living beings. Fig. 6 shows the debris removal efforts that occurred after the earthquake.

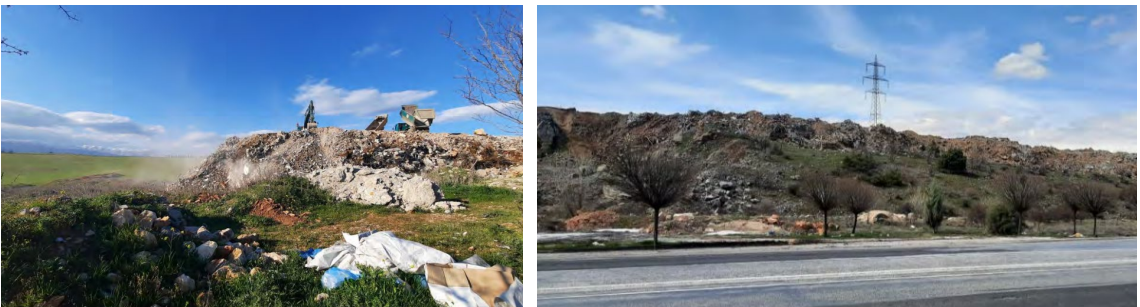
Fig. 7. Adiyaman and Malatya debris dump area [16]

In addition to not being separated according to their physical, chemical, historical significance and characteristics, the wastes were dumped in agricultural and valley areas, empty plains, roadsides, stream beds, olive groves and places close to living spaces, without taking any precautions. This situation causes pollution of water resources, agricultural areas and air, and endangers the health of living beings. In the study conducted by the Chamber of Environmental Engineers [21] on 2 and 3 September 2023, approximately 7 months after the earthquake, a total of 45 solid and dust samples were taken from storage areas, building debris, residential areas, fauna, soil surface and the vehicle used during the study. Asbestos fibers were detected in 16 of the

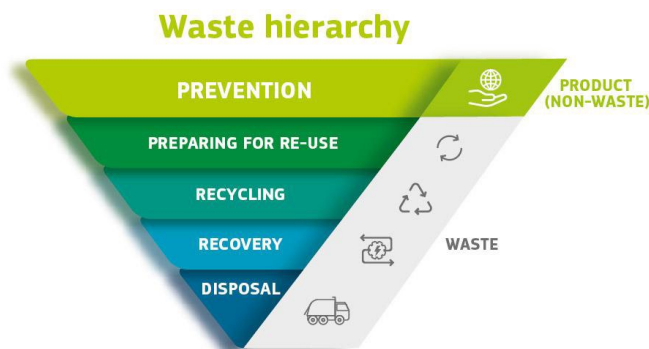
Fig. 9. EU Waste Hierarchy [37]

The European Union is a resource that determines the most ideal rules on "Energy, Climate Change, Environment" and these rules cover all EU member countries. For this reason, instead of examining the waste storage legislation of each country one by one, EU rules were examined. According to the EU's "Waste Hierarchy" landfill is the least

preferred option and is limited to a minimum amount (Fig. 9). The most preferred application is the prevention of waste. In fact, the EU commission limits the share of municipal waste thrown into landfills to 10% by 2035. In other words, it is aimed to recycle and reuse 90% of the waste. In addition, Joint Research Center has developed separate statutes and regulations for "iron, steel and aluminum scrap", "glass cullet" and "copper scrap" in order to transform waste in a correct process [37].
